PROCEEDINGS OF A BOARD OF OFFICERS
 APPOINTED TO INVESTIGATE THE
 CRASH OF MISS AMELIA EARHART AT
 LUKE FIELD, ^{Hawaii - Island} 20 MARCH 1937

OFFICERS APPOINTED TO INVESTIGATE AND REPORT UPON
THE CRASH OF MISS AMELIA EARHART'S AIRPLANE NR 16020 AT LUKE FIELD, OAHU, T.
H., AT 5:50 A.M., MARCH 20, 1937, AND CIRCUMSTANCES RELATING TO HER ARRIVAL
AND STAY AT WHEELER AND LUKE FIELDS, MARCH 18 TO 20, 1937.

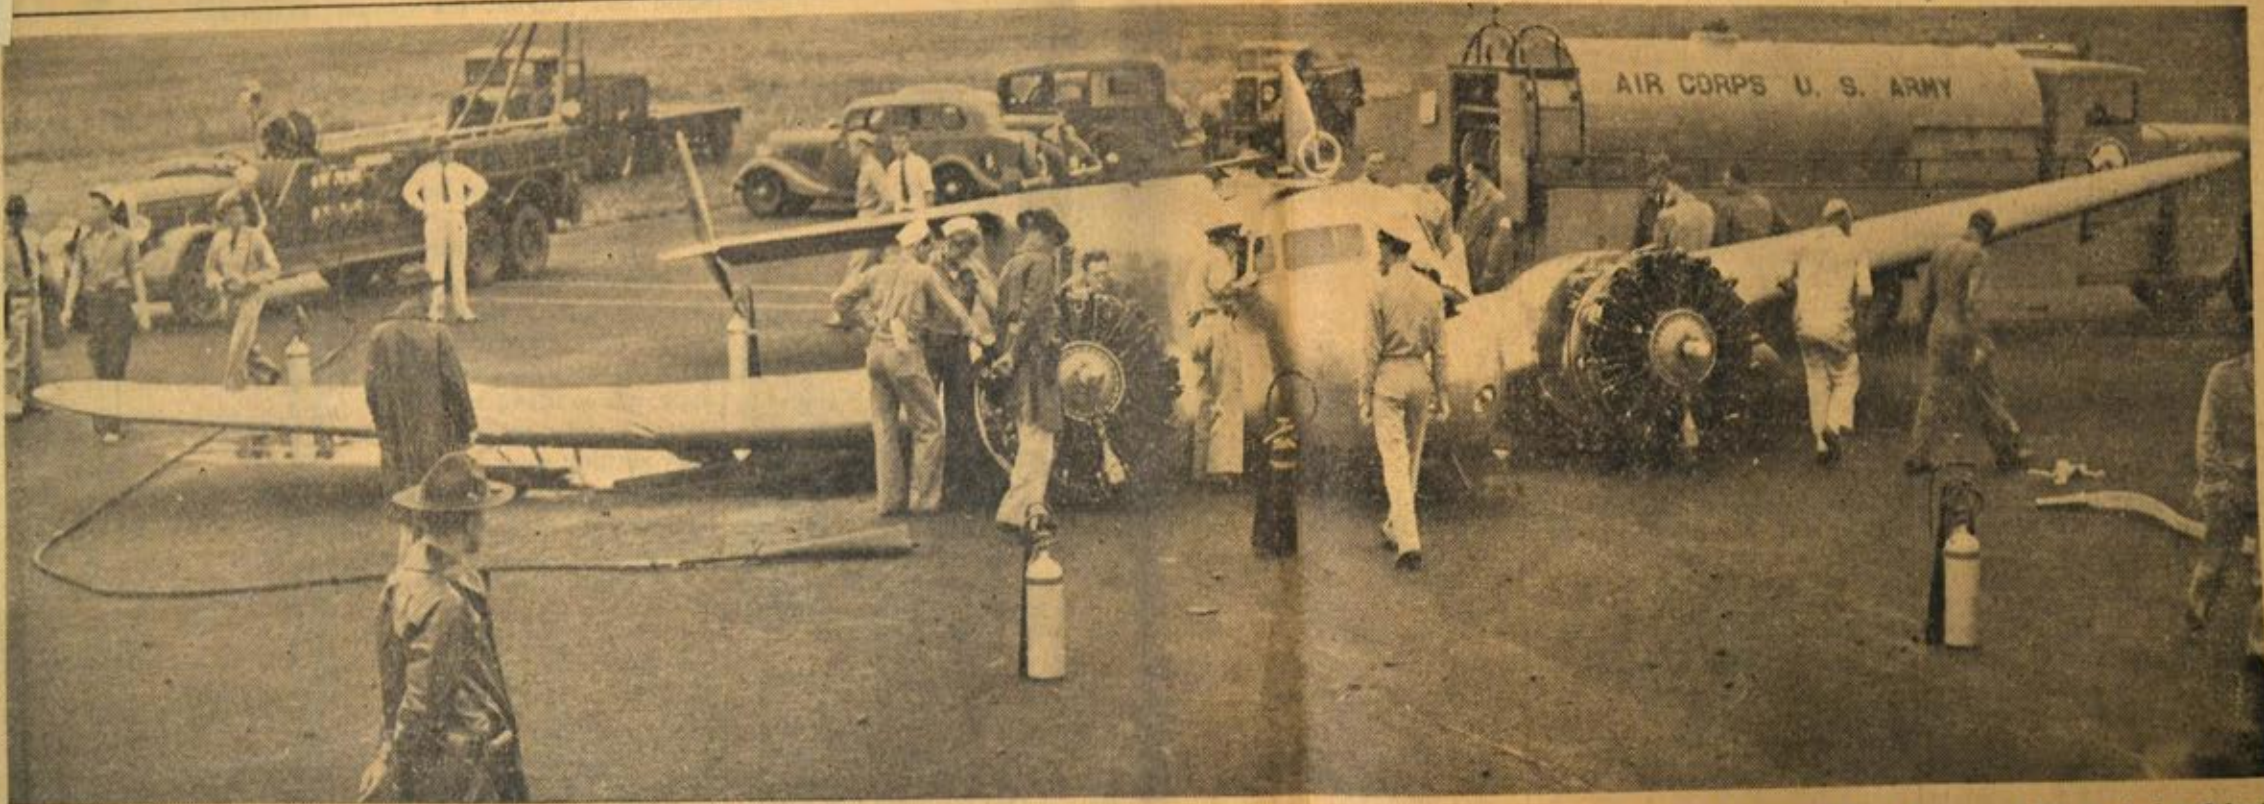
NO ONE HURT.—After crashing in her attempted takeoff for Howland Island at Luke field yesterday morning, Amelia Earhart's sleek twin-motored Lockheed flying laboratory lay crushed and broken. Only clever maneuvering by the premier woman flyer saved the plane's three occupants from death. Here the crew of an army air corps tank truck draws inflammable gasoline from the plane as precaution against further damage to the ship. (Photo by Pan-Pacific Press Bureau.)
